**GLENORCHY CITY COUNCIL**  
**ATTACHMENTS**  
**TUESDAY, 15 MARCH 2016**

## **Targeted Risk Appraisal DRAFT Report Glenorchy to Hobart Cycleway**

| Location: | Glenorchy to Hobart Cycleway |

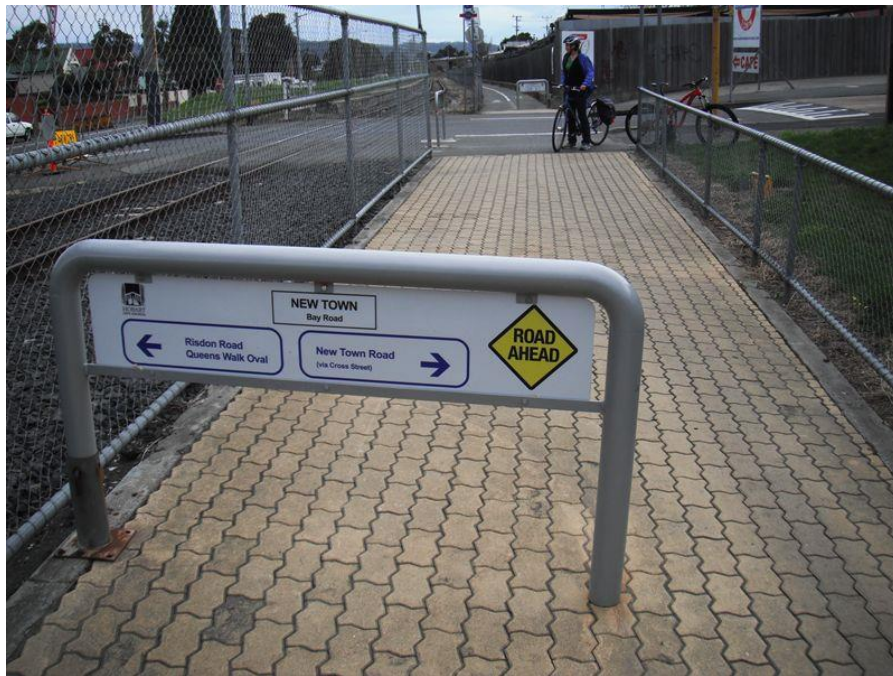
**Fig. 1**

Comment: Signage as displayed at the extreme southern (Hobart) end of the cycleway (Bay Road crossing), which is a section managed by Hobart City Council.

Note that in this location – unlike the road crossings under the management of Glenorchy City Council – one of the chicane gates on either side of the road have been removed which allows easier manoeuvring around. Also worth noting is the signage displayed at this location has been updated to include the Australian Standard style warning symbol with the words *Road Ahead*.

Recommendation: No recommendation is provided for this as it is not the responsibility of Glenorchy City Council.

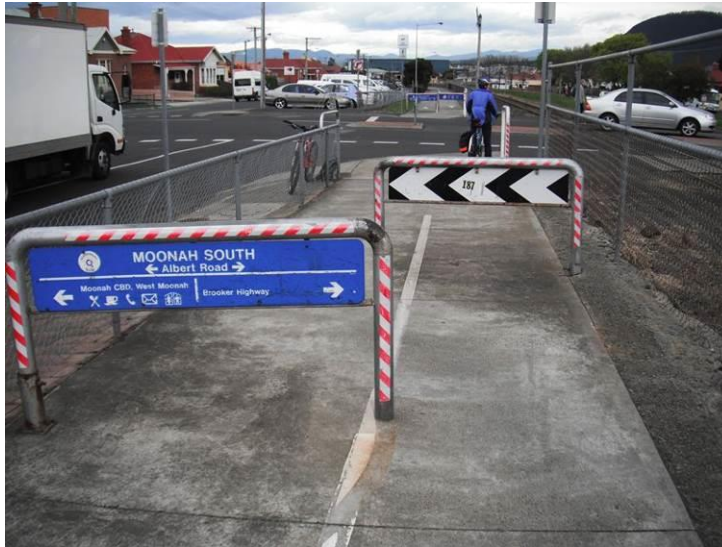
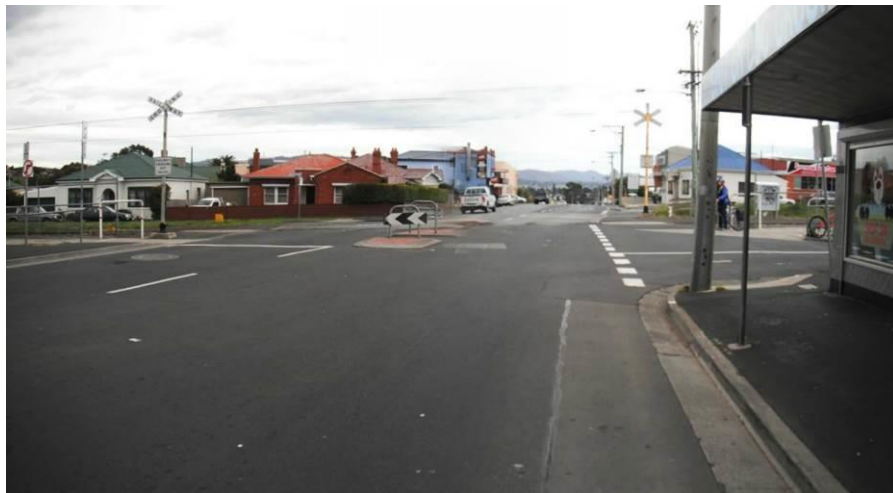
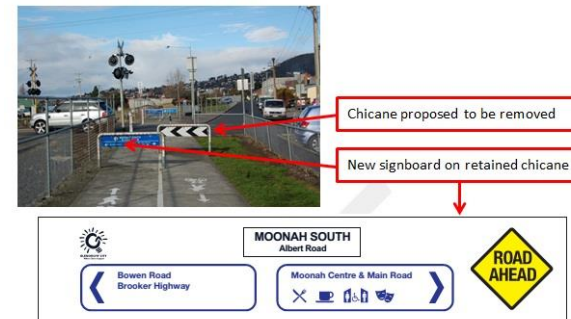
Fig. 2

**Comment:** The first road crossing (travelling South to North) in the section under the management of Glenorchy City Council, with the bottom image showing the view from the road (Albert Road).

Note that there is no warning signage for vehicle drivers of cyclists and pedestrians crossing. Neither is there any warning signage on the chicane gates warning of the road crossing.

**Recommendation:** Council's proposal is recommended to be implemented for all such road crossings, as this will provide better warning for cyclists of the impending road crossing, decrease the likelihood of collisions between users travelling in opposite directions, and in some cases (where the chicane gates are located closer to the road) allow riders to get clear of the road quicker.

Council should also consider renewing all reflective tape to ensure the entireties of the remaining barriers are clearly visible at night.

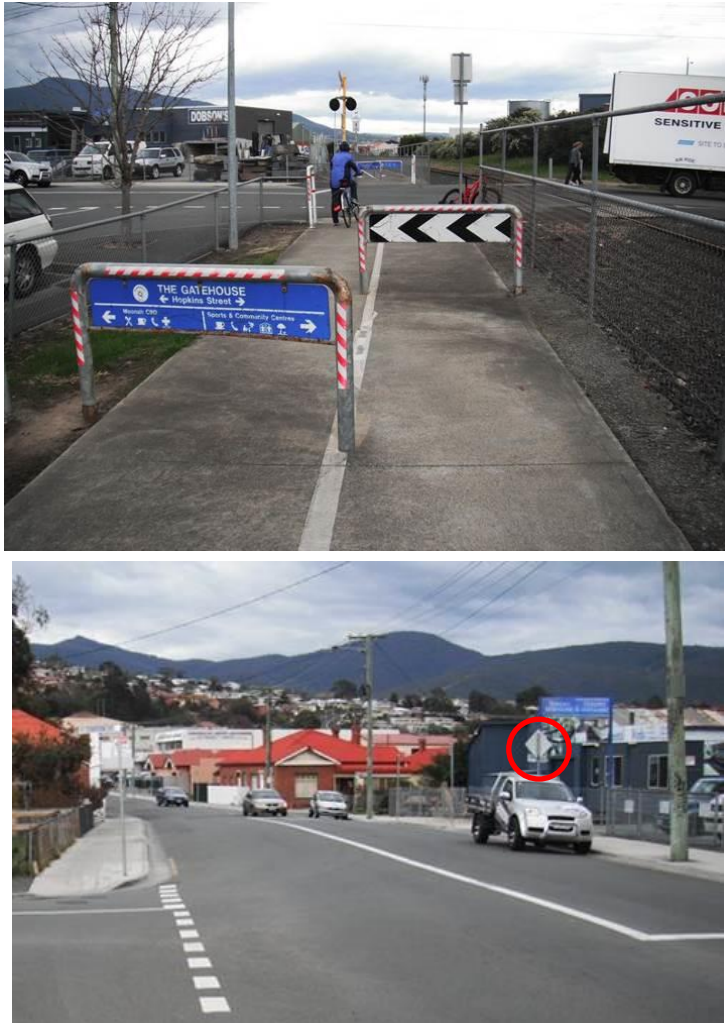
Fig. 3

Comment: Second road crossing (travelling South to North) under the management of Glenorchy City Council, with the bottom image showing the view to the West along the road (Hopkins St) from the crossing point.

Note that at this location (as indicated by the red circle) that warning signage is provided on the approach to the crossing for road users (the same is provided on the other side of the crossing for vehicles travelling west).

Recommendation: Council's proposal is recommended to be implemented for all such road crossings, as this will provide better warning for cyclists of the impending road crossing, decrease the likelihood of collisions between users travelling in opposite directions, and in some cases (where the chicane gates are located closer to the road) allow riders to get clear of the road quicker.

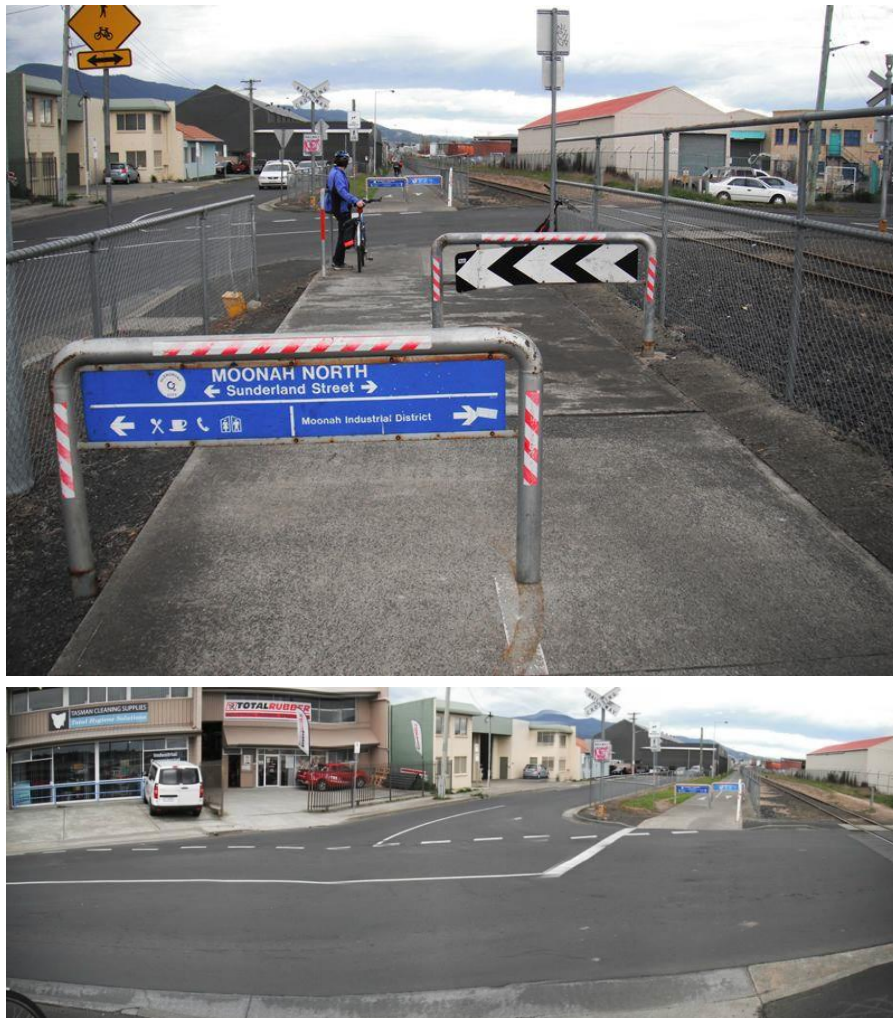
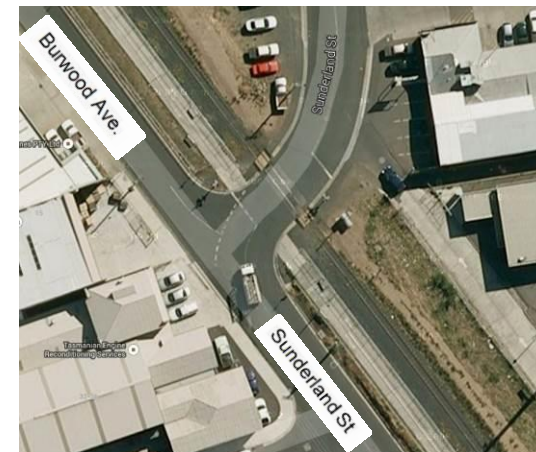
Fig. 4

Comment: Third road crossing (travelling South to North) under the management of Glenorchy City Council (Sunderland Street), with the bottom image showing the intersection of Sunderland St and Burwood Avenue from the crossing point.

It is noted that warning signage is provided for road users approaching from all three directions.

This crossing is somewhat unique with the way Sunderland St. bends just prior to the crossing point, as well as the way that vehicles may also be turning in from Burwood Avenue (see google image below). This may make it difficult and/or confusing for pathway users to ensure the road is clear in all three directions.

Recommendation: Council's proposal is recommended to be implemented for all such road crossings, as this will provide better warning for cyclists of the impending road crossing, decrease the likelihood of collisions between users travelling in opposite directions, and in some cases (where the chicane gates are located closer to the road) allow riders to get clear of the road quicker.

Council should also consider renewing all reflective tape to ensure the entireties of the remaining barriers are clearly visible at night.

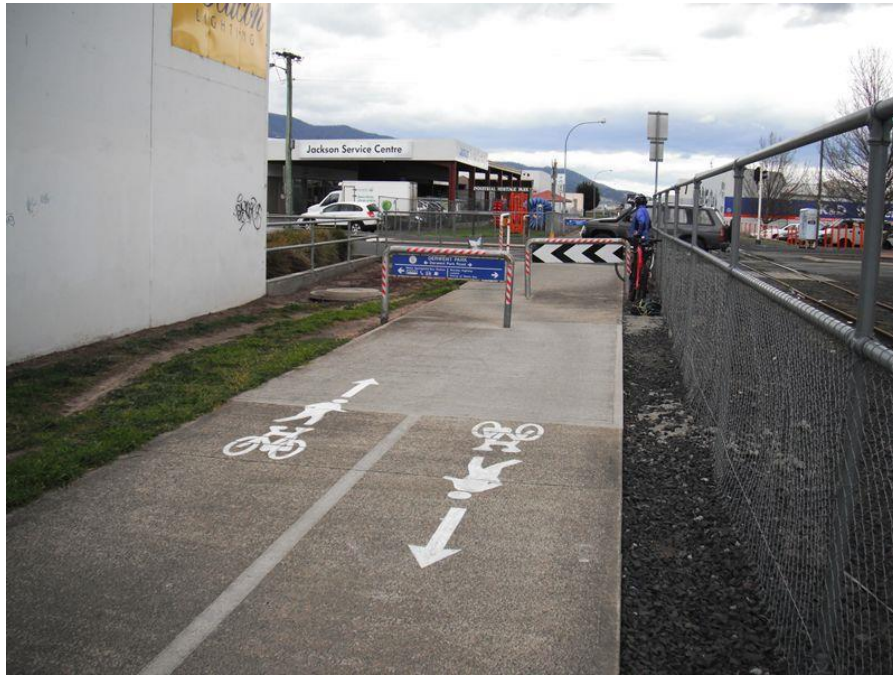
Fig. 5

Comment: Fourth road crossing (travelling South to North) under the management of Glenorchy City Council (Derwent Park Road).

Note the building on the left significantly reduces the ability to see up Derwent Park Road to the left. While this is quite a busy road, warning signage for road users is provided on approach from both directions, and the presence of traffic lights to the left makes it likely that traffic will be travelling at a relatively slow speed.

Recommendation: Council's proposal is recommended to be implemented for all such road crossings, as this will provide better warning for cyclists of the impending road crossing, decrease the likelihood of collisions between users travelling in opposite directions, and in some cases (where the chicane gates are located closer to the road) allow riders to get clear of the road quicker. Council should also consider renewing all reflective tape to ensure the entireties of the remaining barriers are clearly visible at night.

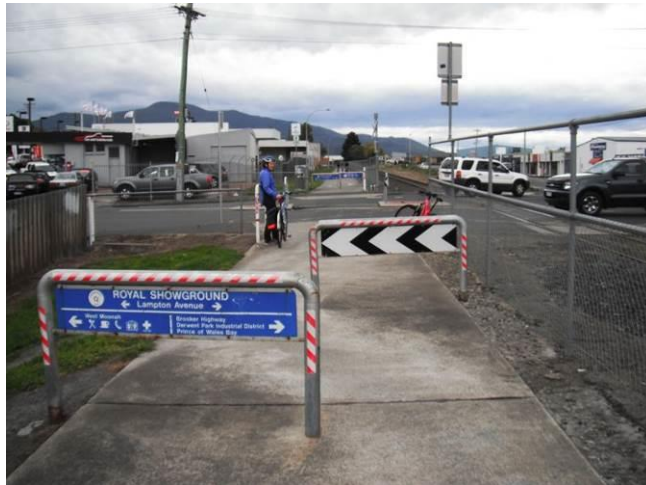
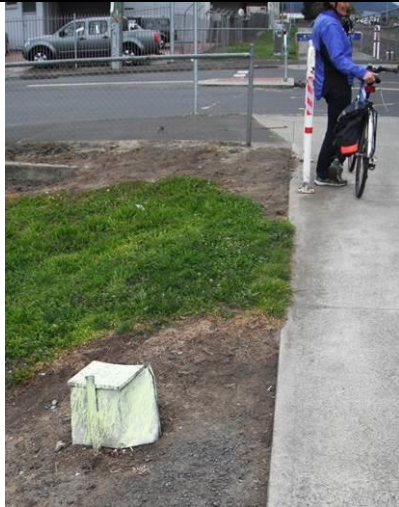
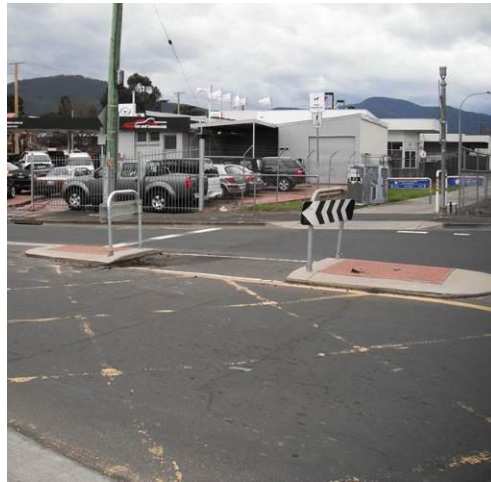
Fig. 6

Comment: Fifth road crossing (travelling South to North) under the management of Glenorchy City Council (Lampton Avenue).

The bottom-left image shows some type of utility box that, while highlighted bright yellow, is located quite close to the pathway and may be a particular hazard to a cyclist who chooses to ride to the left of the chicane (which evidently appears to have been done on numerous occasions judging by the worn grass).

Again the presence of an intersection with traffic lights in very close proximity to this crossing means traffic is likely to be travelling at a relatively low speed, however it was also noted that vehicle drivers were seen to have *squeezed* through this section on the right (creating 2 lanes of traffic) in order to get closer to the intersection in preparation for a right turn. With some

modification to the footpath and road there should be sufficient space to widen the road and provide a wider refuge island.

**Recommendation:** Council's proposal is recommended to be implemented for all such road crossings, as this will provide better warning for cyclists of the impending road crossing, decrease the likelihood of collisions between users travelling in opposite directions, and allow riders to get clear of the road quicker. Council should also consider renewing all reflective tape to ensure the entireties of the remaining barriers are clearly visible at night.

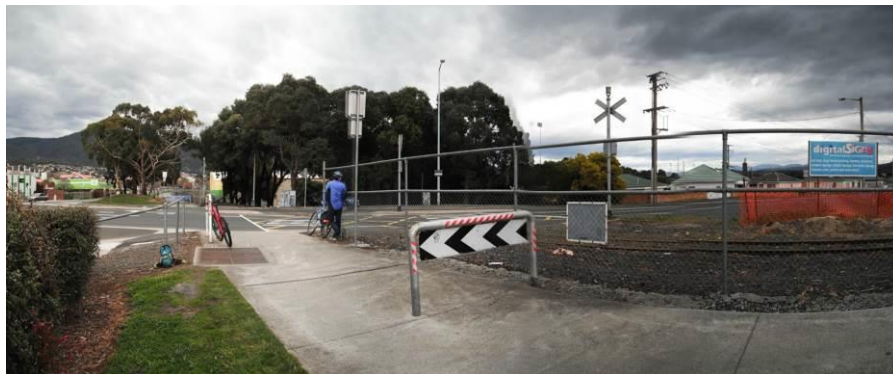
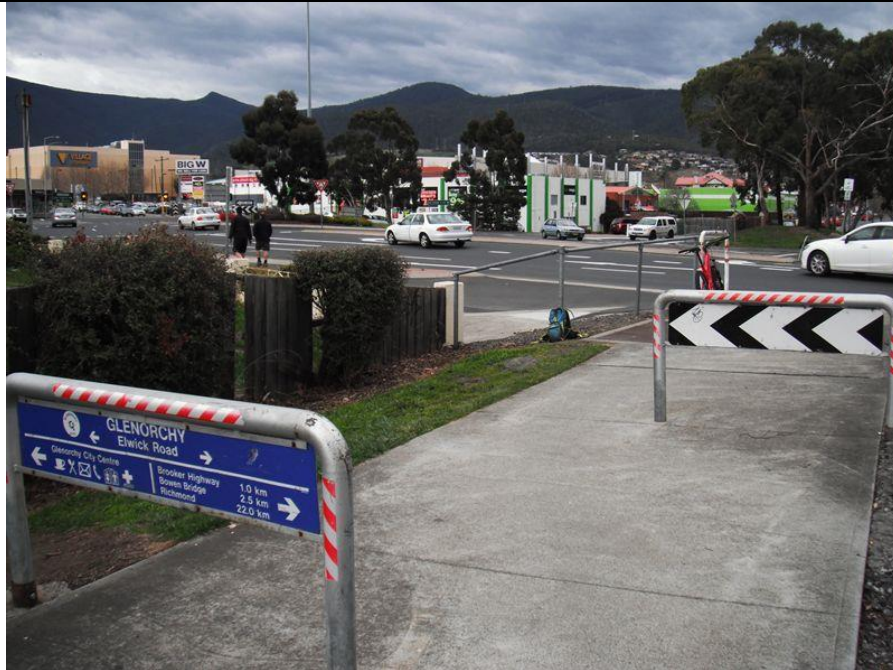
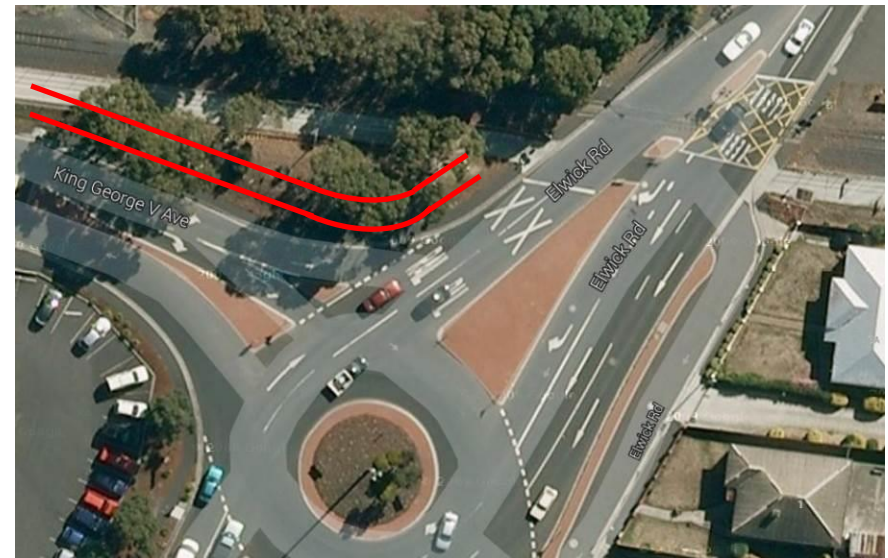
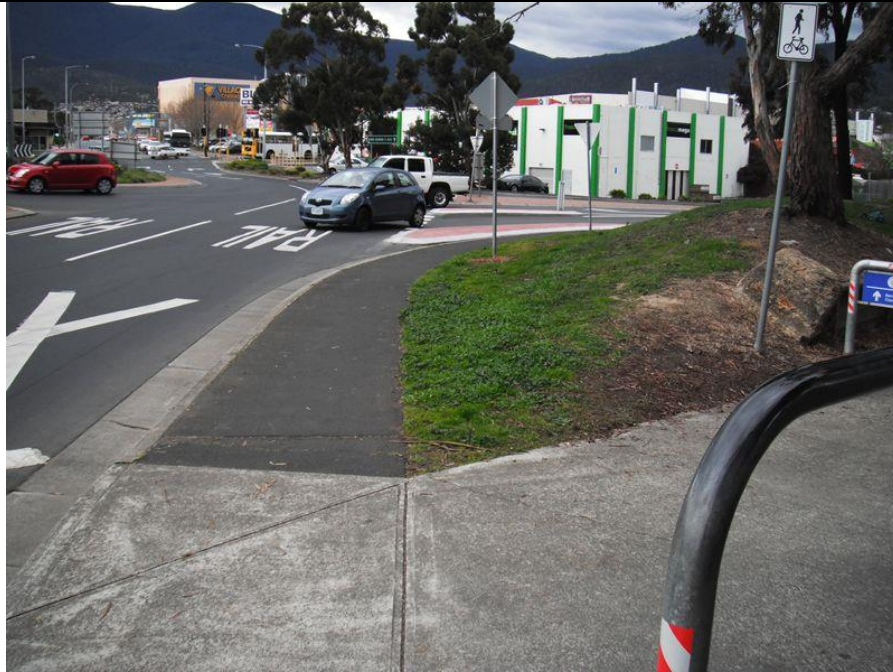
**Fig. 7**

**Comment:** Sixth road crossing (travelling South to North) under the management of Glenorchy City Council (Elwick Road). Really the most complex and high risk road crossing on the length of the pathway with the road being extremely busy and a round-about located just meters to the left (South) of the crossing, vehicle drivers have *many* factors on which to concentrate/look for other than pathway users crossing the road.

Finally, it is also noted that – while reportedly compliant with respective standards – the width of the pedestrian refuge at this crossing is also quite

limited, meaning that a cyclist waiting there may still be slightly exposed to road traffic.

**Recommendation:** Council's proposal is recommended to be implemented for all such road crossings, as this will provide better warning for cyclists of the impending road crossing, decrease the likelihood of collisions between users travelling in opposite directions, and allow riders to get clear of the road quicker.

As a long term strategy, Council should consider potential re-designs of this crossing and/or intersection through construction of a bridge or simply re-routing the pathway in such a way that ensures road users are more aware of the presence of the pathway crossing. Below is an example of one potential option – which would mean the pathway users more visible to road users – however advice should be sought from suitably qualified traffic engineers.

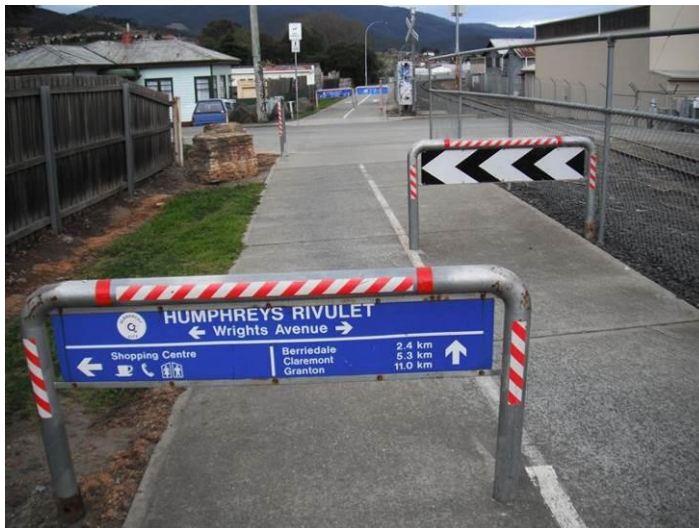
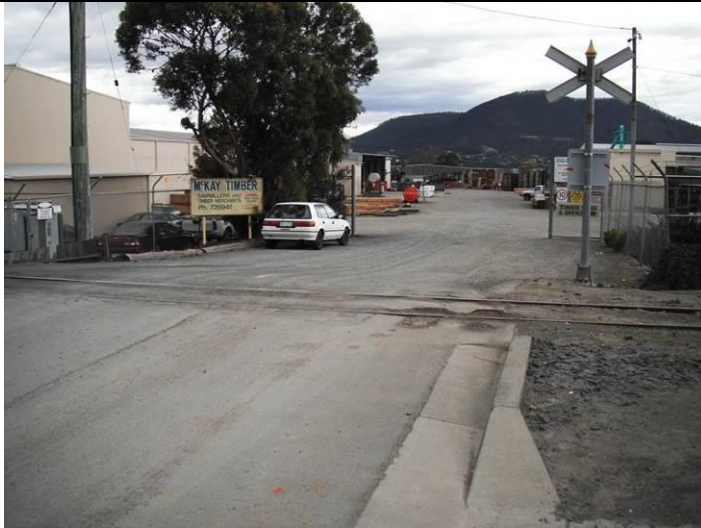
Fig. 8

Comment: Seventh road crossing (travelling South to North) under the management of Glenorchy City Council (Wrights Avenue).

It is noted that no warning signage is provided to road users from either direction entering or exiting the timber yard to warn of the crossing pathway traffic.

Recommendation: Council's proposal is recommended to be implemented for all such road crossings, as this will provide better warning for cyclists of the impending road crossing, decrease the likelihood of collisions between users travelling in opposite directions, and allow riders to get clear of the road quicker.

Council should also consider renewing all reflective tape to ensure the entireties of the remaining barriers are clearly visible at night.

Council should also ensure that warning signage for road users entering and exiting the timber yard to warn of the crossing pathway traffic.

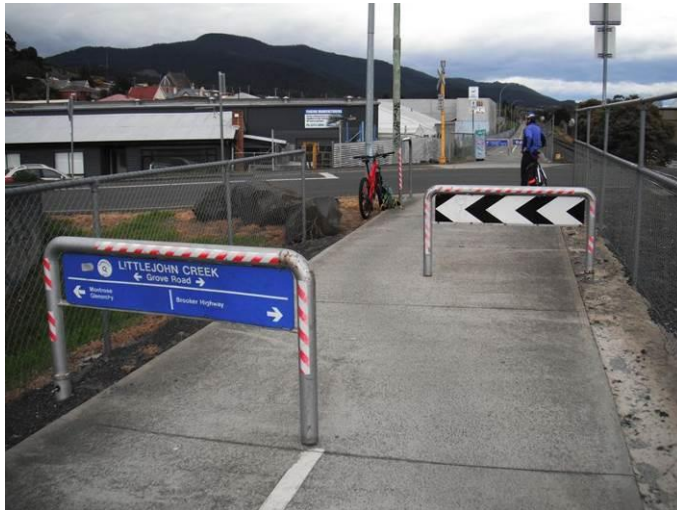
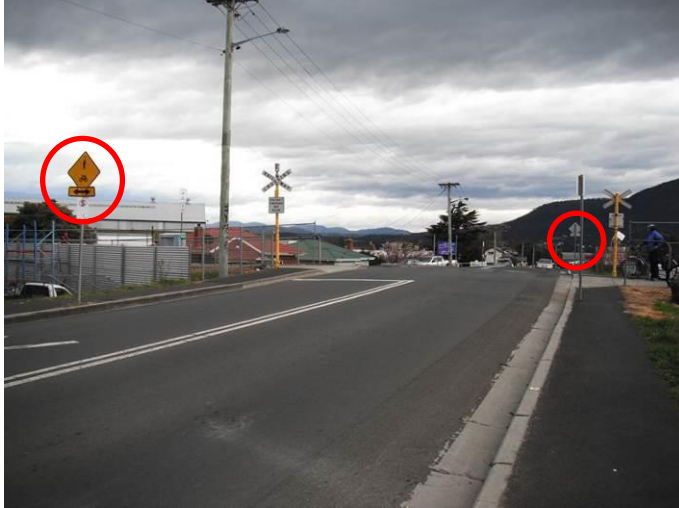
Fig. 9

Comment: Eighth road crossing (travelling South to North) under the management of Glenorchy City Council (Grove Road Avenue).

Recommendation: Council's proposal is recommended to be implemented for all such road crossings, as this will provide better warning for cyclists of the impending road crossing, decrease the likelihood of collisions between users travelling in opposite directions, and allow riders to get clear of the road quicker.

Council should also consider renewing all reflective tape to ensure the entireties of the remaining barriers are clearly visible at night.

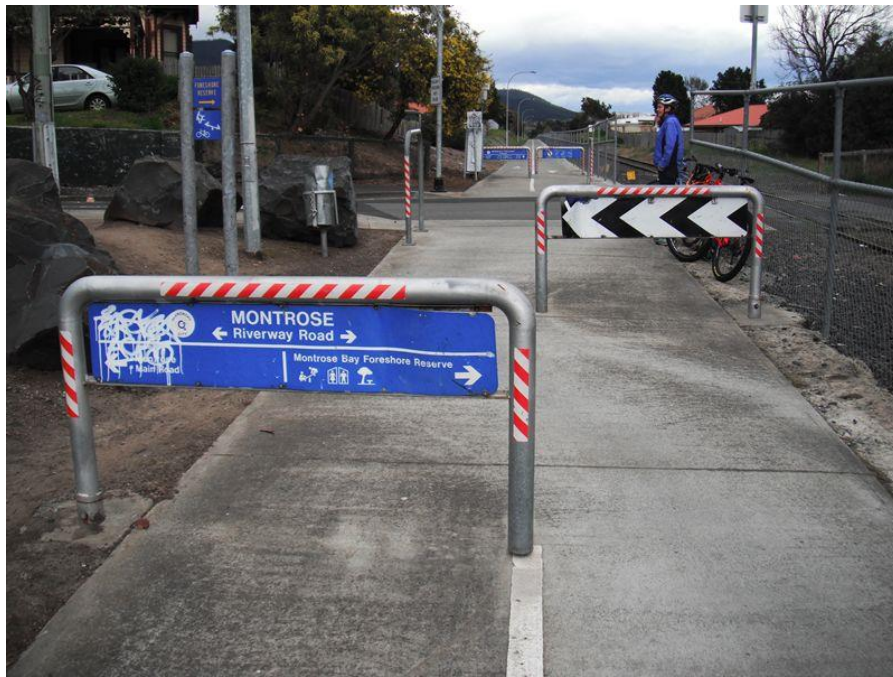
Fig. 10

Comment: Ninth road crossing (travelling South to North) under the management of Glenorchy City Council (Riverway Rd).

Recommendation: Council's proposal is recommended to be implemented for all such road crossings, as this will provide better warning for cyclists of the impending road crossing, decrease the likelihood of collisions between users travelling in opposite directions, and allow riders to get clear of the road quicker.

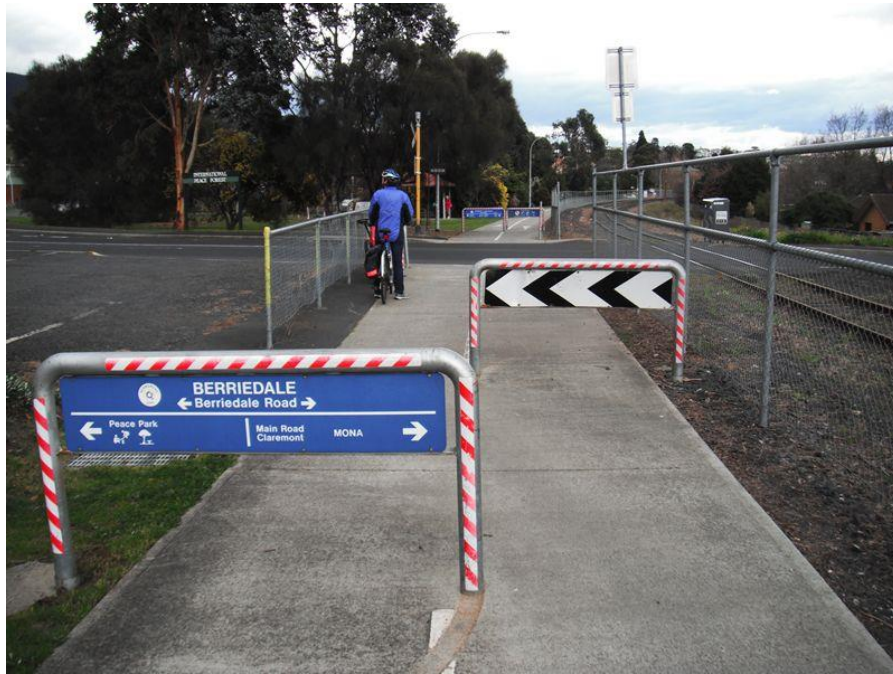
Fig. 11

Comment: Tenth road crossing (travelling South to North) under the management of Glenorchy City Council (Barriedale Rd).

While line of sight for road users is relatively clear from both directions, it is noted that no warning signage is provided to road users from either direction of the pathway traffic crossing the road.

Recommendation: Council's proposal is recommended to be implemented for all such road crossings, as this will provide better warning for cyclists of the impending road crossing, decrease the likelihood of collisions between users travelling in opposite directions, and allow riders to get clear of the road quicker.

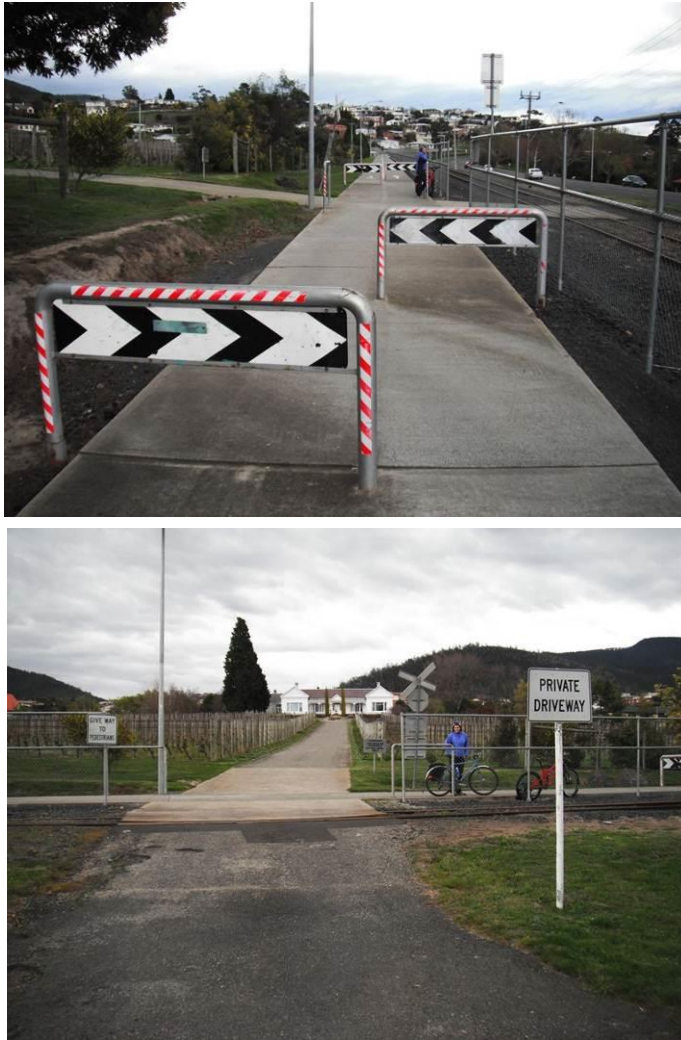
Fig. 12

Comment: At this point the pathway crosses a driveway to a private residence.

Recommendation: Council's proposal is recommended to be implemented for all such crossings, as this will provide better warning for cyclists of the impending crossing, decrease the likelihood of collisions between users travelling in opposite directions, and allow riders to get clear of the driveway quicker.

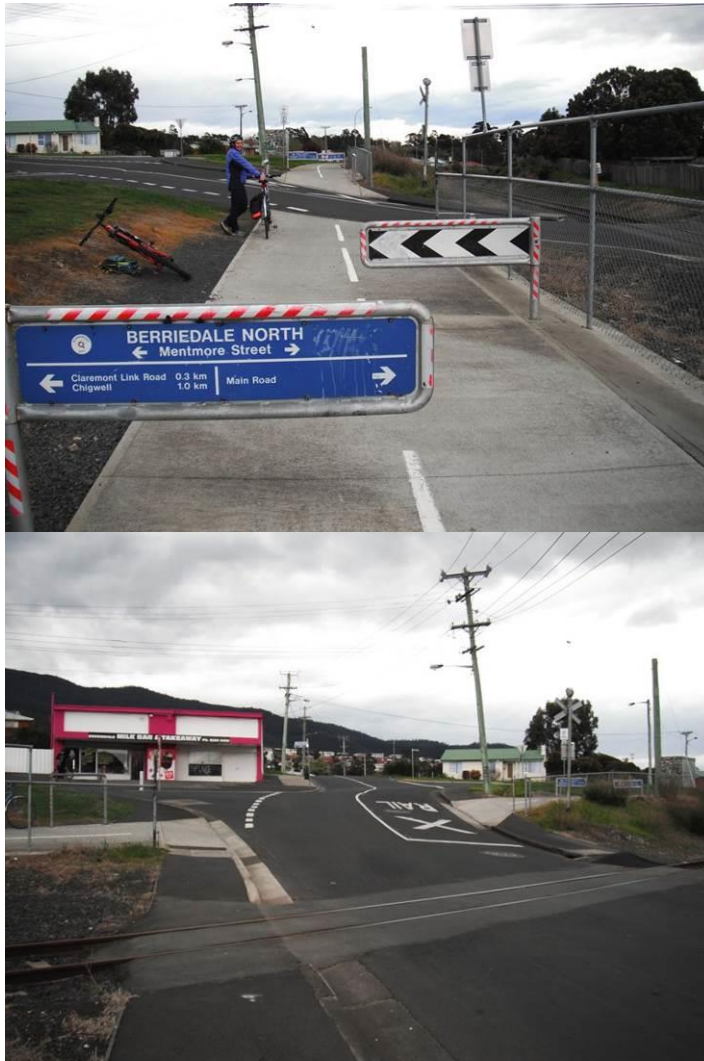
Fig. 13

Comment: Eleventh road crossing (travelling South to North) under the management of Glenorchy City Council (Mentmore St).

It is also noted that no warning signage is provided to road users from either direction of the pathway traffic crossing the road.

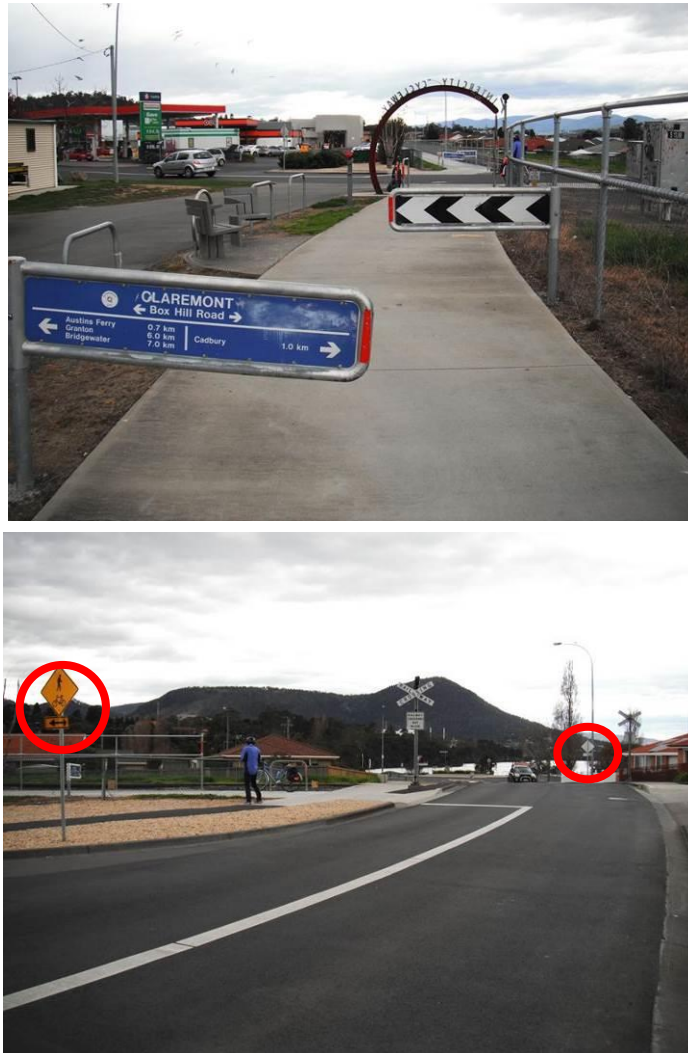
Fig. 14

Comment: Twelfth road crossing (travelling South to North) under the management of Glenorchy City Council (Box Hill Road) and the formal Northern start/finish of the Intercity Cycleway.

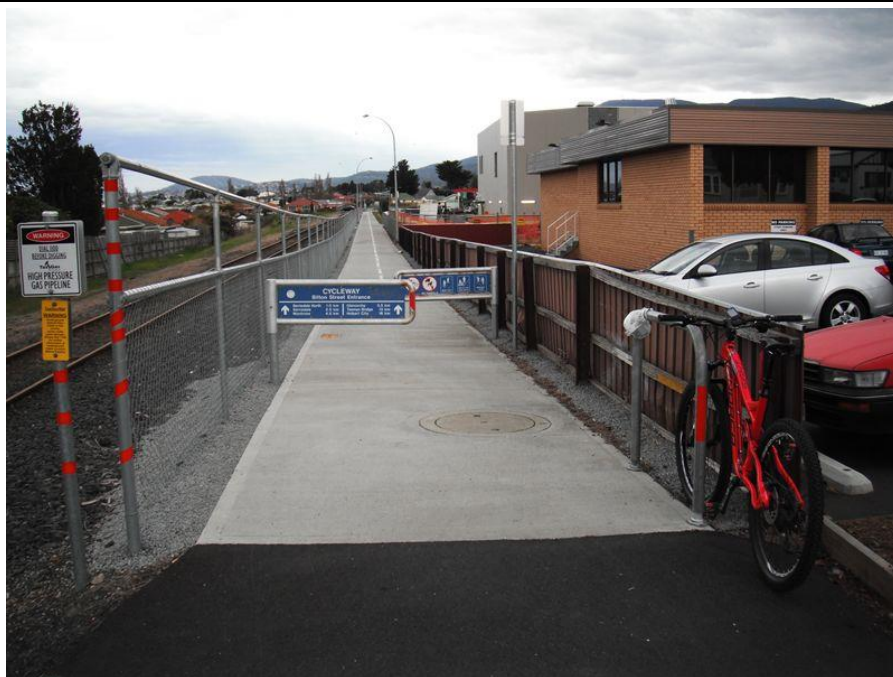
Fig. 15

Comment: The northern end of the pathway visited for the purpose of this appraisal (Bilton Street).

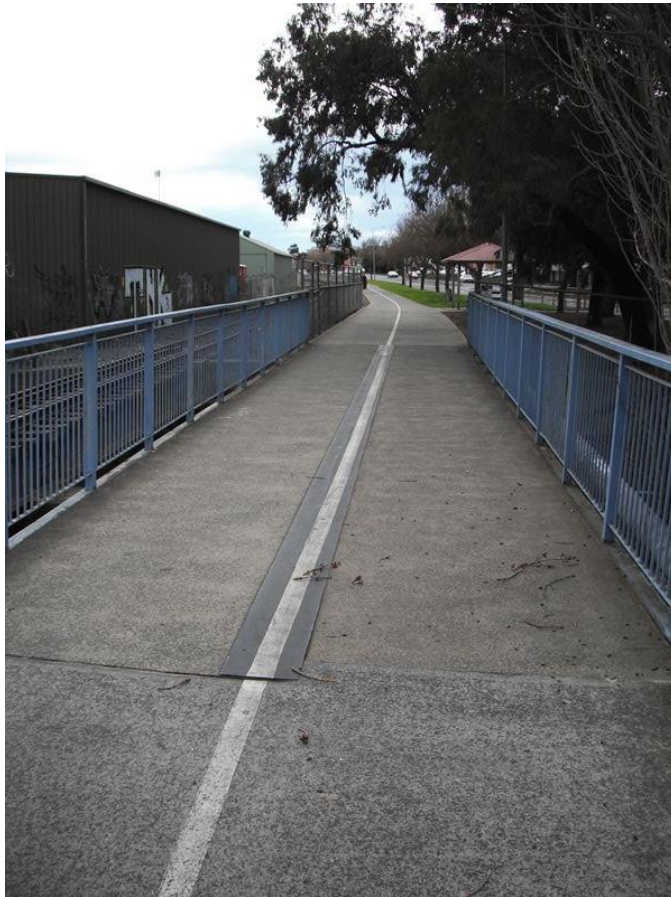
Fig. 16

Comment: This image shows the metal strip in the middle of the pathway on which a cyclist has reportedly slipped causing him to lose control and crash into the fencing/barriers.

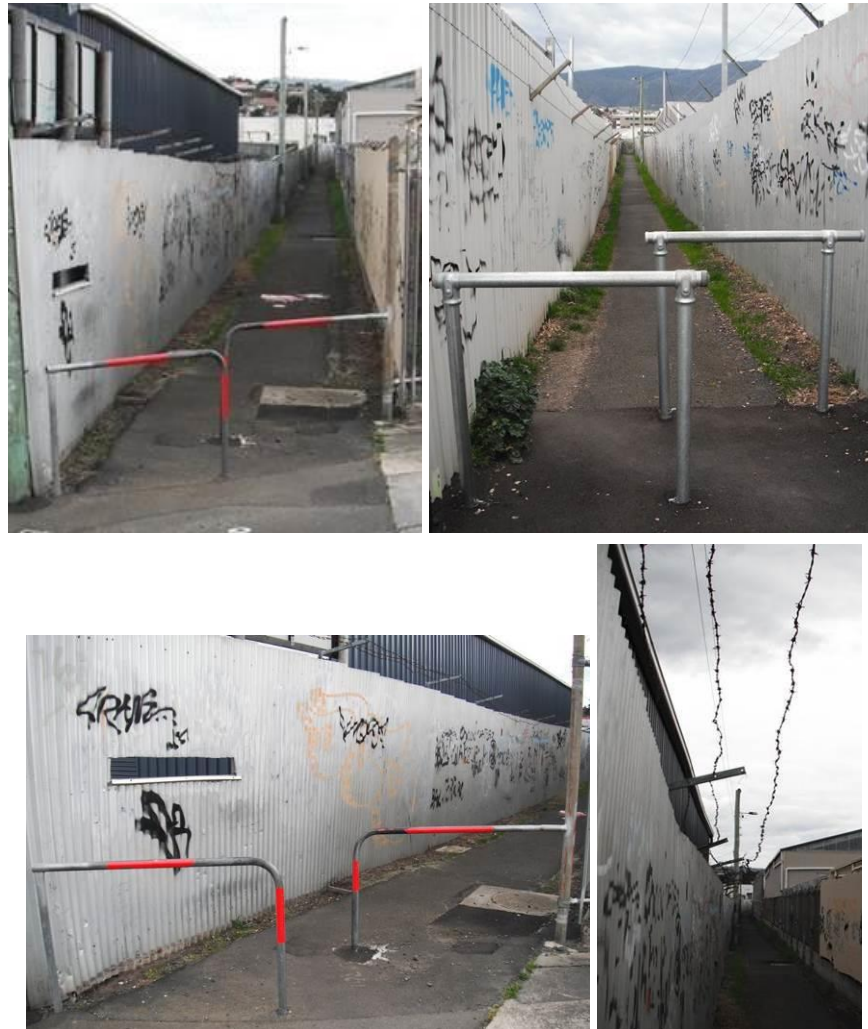
Fig. 17

Comment: While this laneway does not form part of the Intercity Cycleway and is not marked as a Shared Pathway, it does connect to it at the Sunderland St crossing shown in Fig. 4, and as such it is likely that some cyclists will use it as an access route despite its narrow width.
