**GLENORCHY CITY COUNCIL**  
**ATTACHMENTS**  
**TUESDAY, 15 MARCH 2016**

## **Targeted Risk Appraisal DRAFT Report Glenorchy to Hobart Cycleway**

| Location: | Glenorchy to Hobart Cycleway |

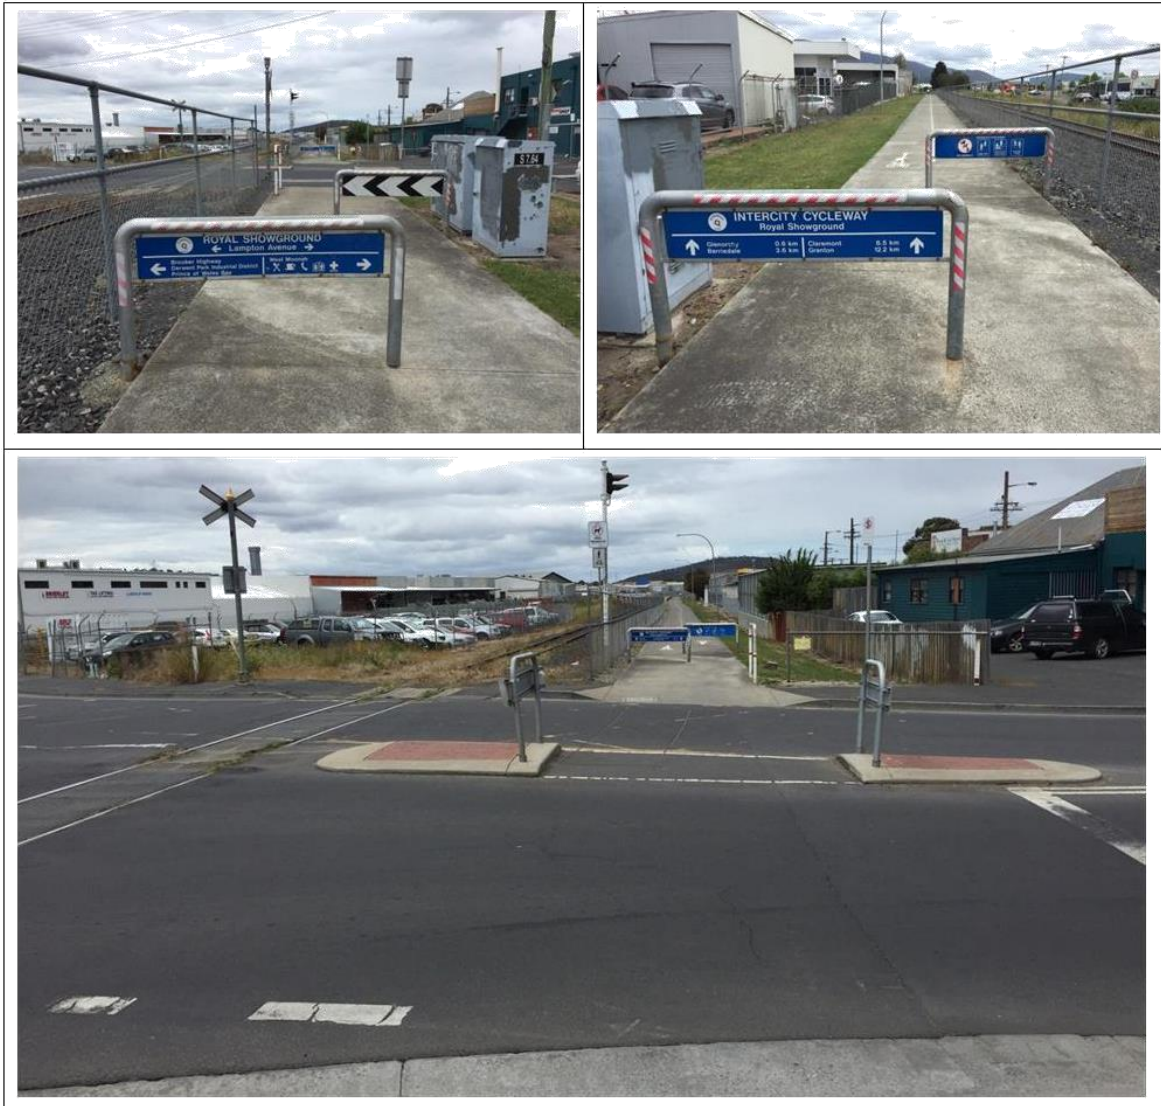
**Figure 2 Lampton Avenue Crossing**

Austroads 2009 states that central median islands should be incorporated at road crossings with volumes greater than 3,000 vehicles per day. The majority of road junctions of the Cycleway would fall into this category, whereas only 4 junctions have refuge islands. An example of a narrow refuge island within the road crossing (Lampton Avenue) is shown in Figure 2 as an example. A typical example of a road crossing without a refuge island is provided in Figure 3 (Grove Road).

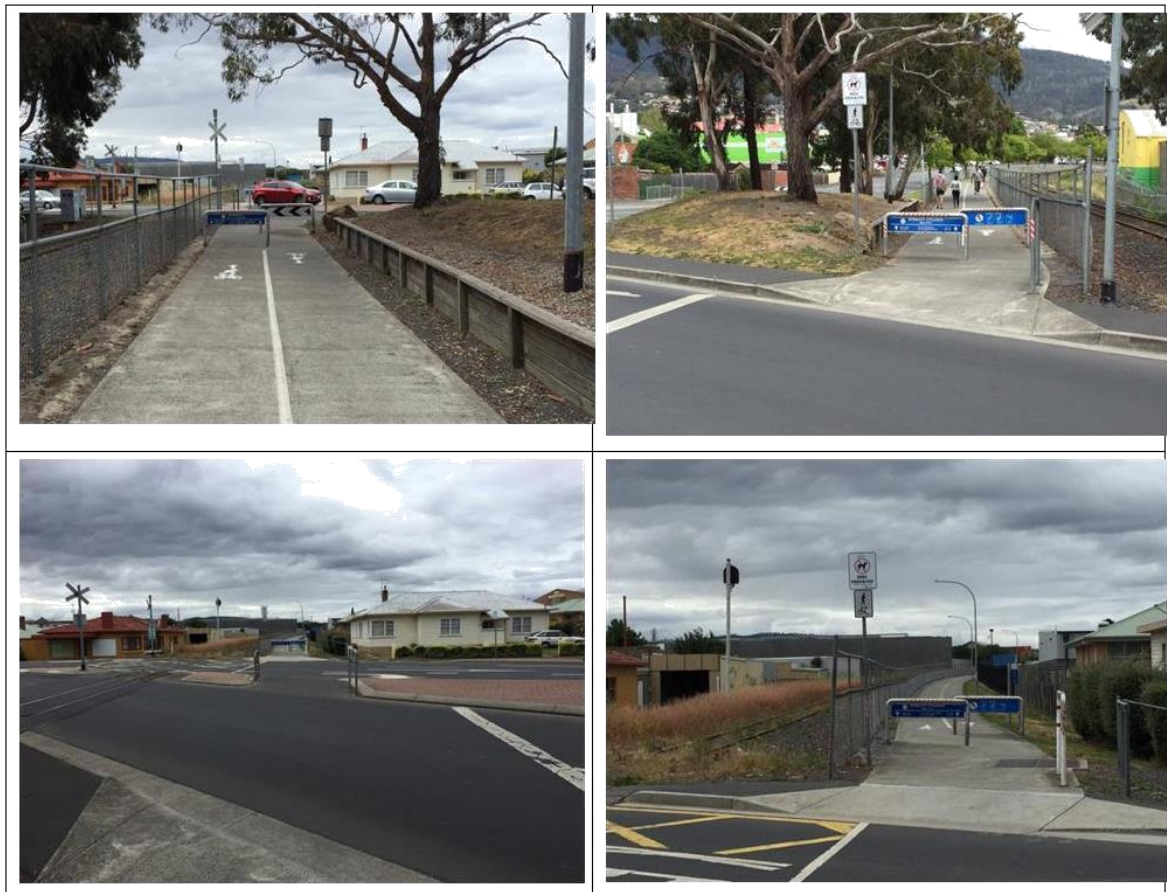
**Figure 4 Elwick Road Crossing**

In light of the complex high-volume road crossing at this location the chicane gates have a varied impact on road safety. This is highlighted as follows:

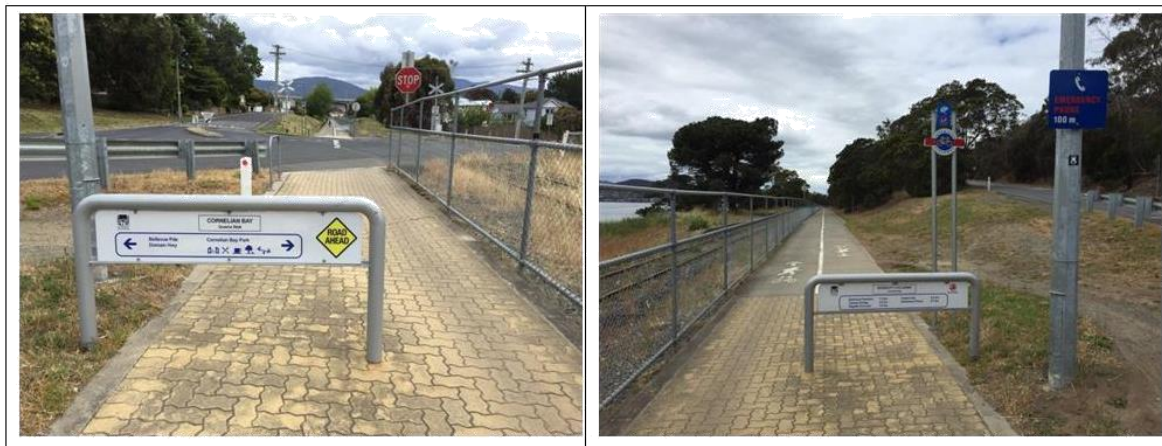
**Figure 7 Queens Walk Crossing (HCC Comparison)**

An assessment was made of chicane gate junction treatment at Queens Walk in the Hobart City Council municipality. This junction has a single chicane gate with a textured and coloured pavement treatment on the approaches to the road junction. This is shown in Figure 7.

In general terms it reduces many of the risks associated with the existing terminal treatment.
